The potential for imminent danger to human life and the environment from the Mirador open-pit copper mine in south-eastern Ecuador

Submitted to the Inter-American Commission on Human Rights

E-Tech International

Report prepared at the request of E-Tech International  
Submitted 19 February 2019  
Revised 26 February 2019

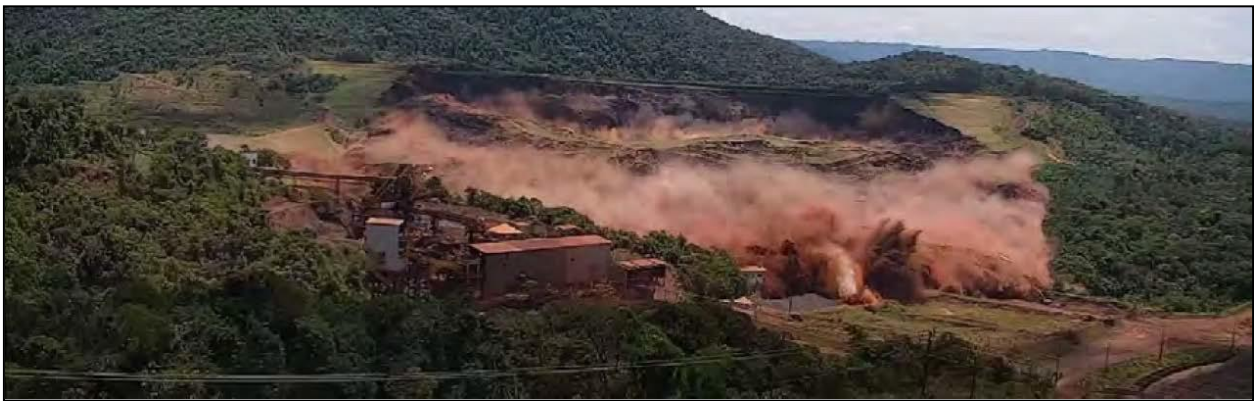
**Figure 4. Brumadinho Fault, Brazil, 18 seconds after onset**

The immediate cause of the failure was static liquefaction, which was triggered by heavy rainfall. Common features between the Mirador and Brumadinho sites are (1) steep embankments (2) construction using the "upstream" method and (3) excess water behind the dam.

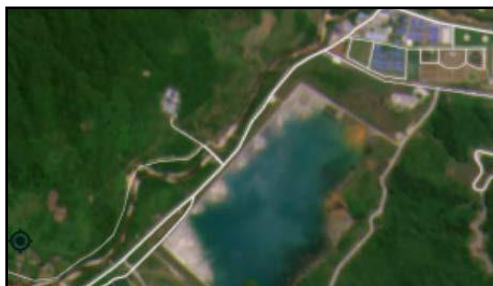
**Figure 6. Quimi spring saturated in June 2020**

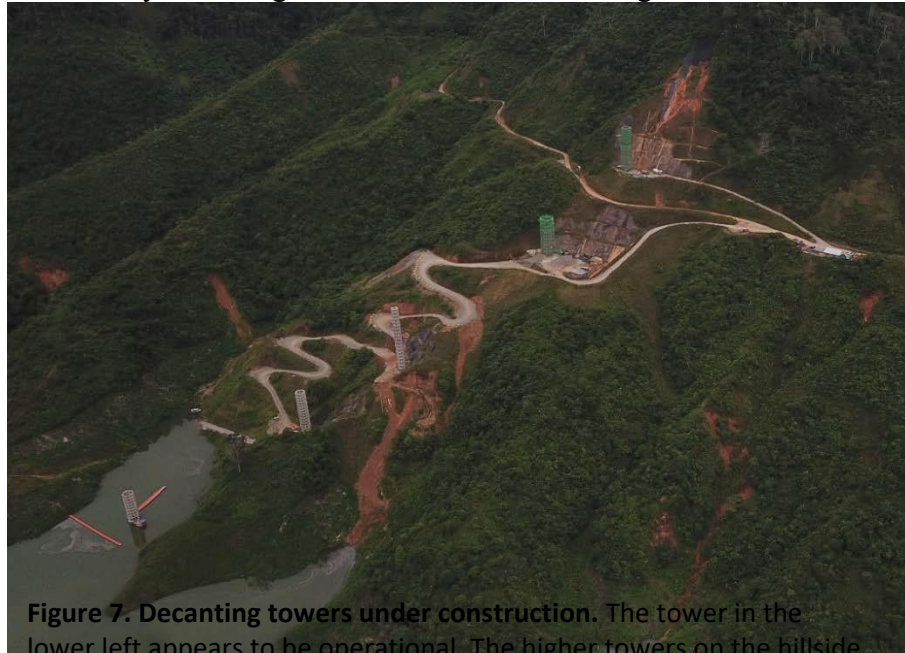
**Figure 7. Decanting towers under construction.** The tower in the lower left appears to be operational. The higher towers on the hillside are for future use. End of May 2022. *Source: local supplier*

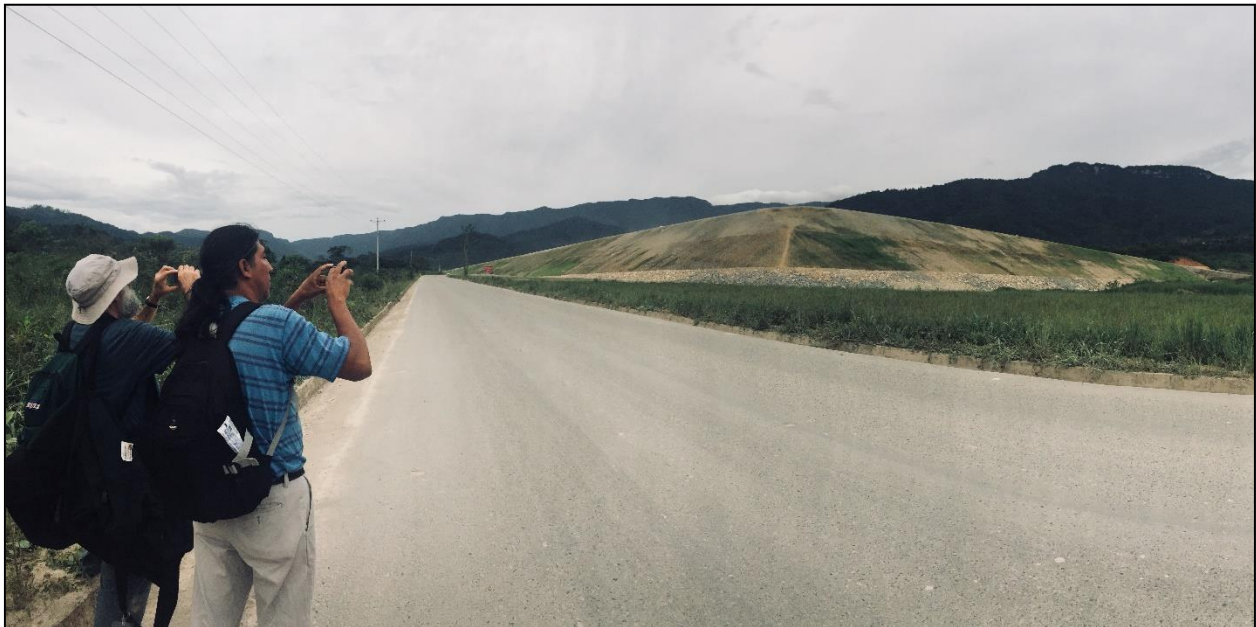
**Figure 1.** The author (left) and Luis Sanchez Zhiminaycela (activist in Comunidad Amazónica de Acción Social Cordillera del Cóndor Mirador) study the initial dam of the Quimi tailings dam at the Mirador mine. Photo taken by Evelyne Blondeel on 6 November 2018.

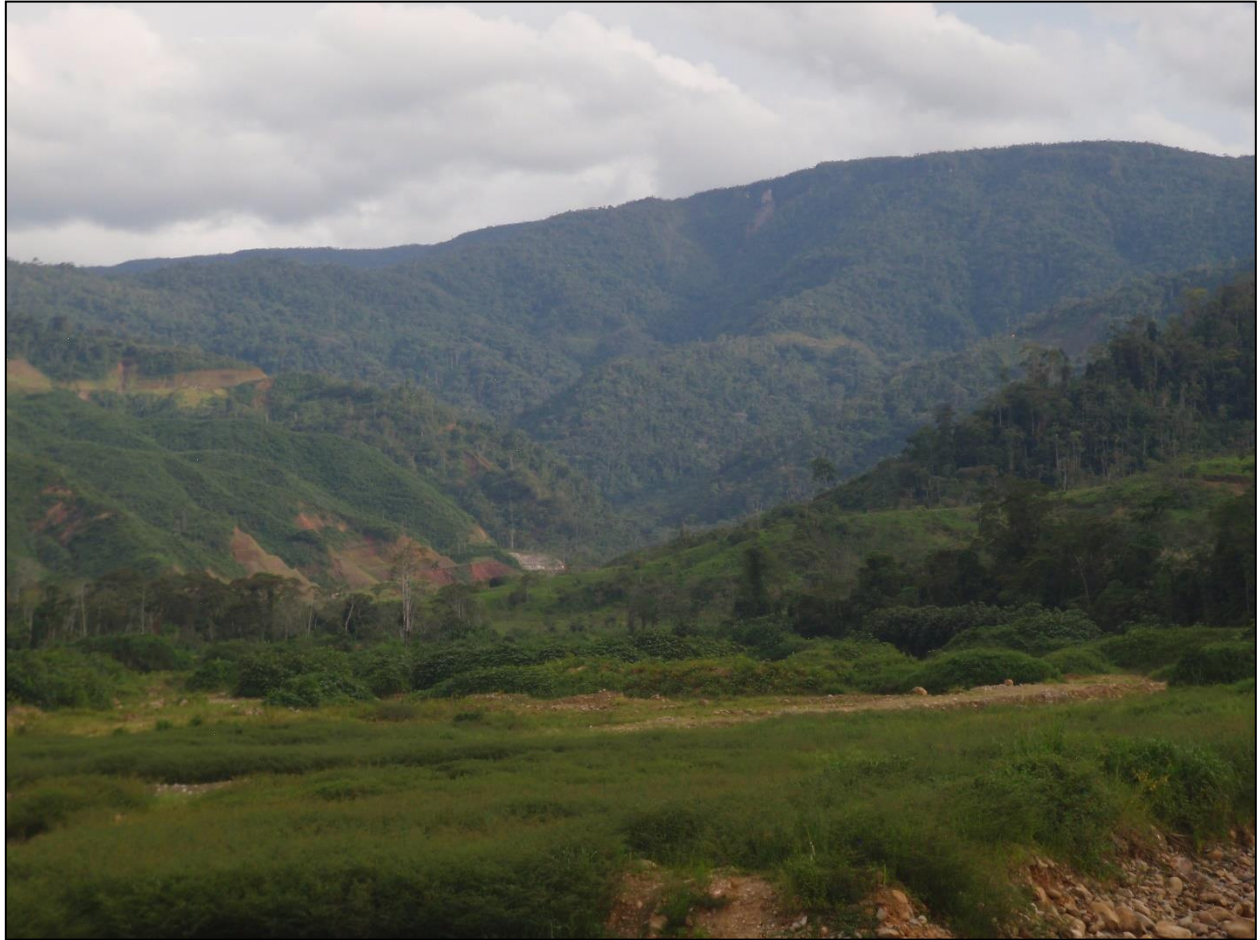
**Figure 12.** The cost of construction would be cheaper for the Tundayme tailings dam because it is possible to take advantage of the steep slopes of the Tundayme valley (shown above) for tailings confinement (Cardno, 2014a). However, the steep slope of the valley (about 13%) in the direction towards the Quimi river (see Fig. 11) increases the risk of failure due to the increased gravitational force that would act on the dam. In addition, the steep slopes pose a risk of landslides over the tailings pond, which could lead to dam failure by flooding. Photo taken by the author on 6 November 2018.

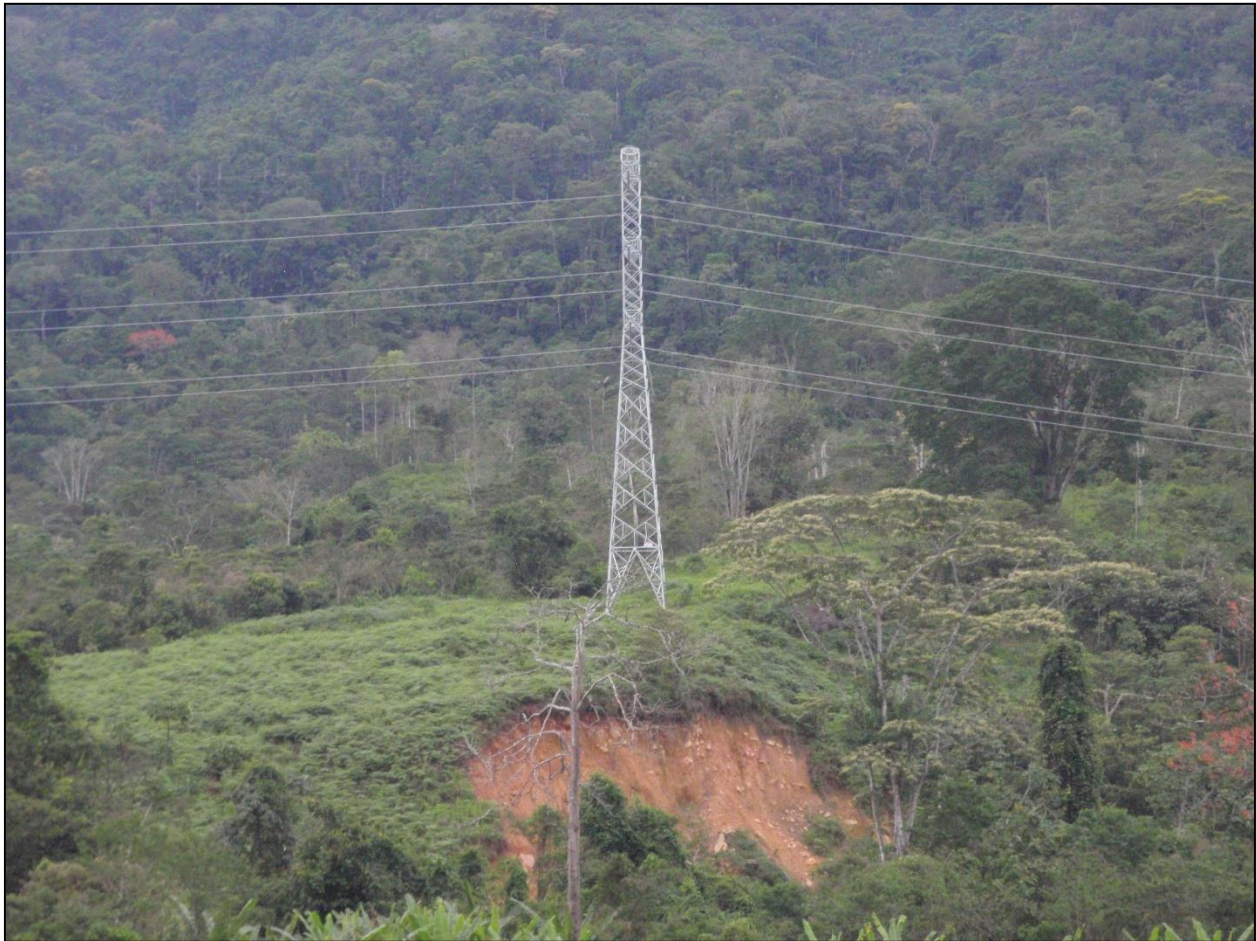
**Figure 15.** The high erosion rate in the project area is indicated by the landslide scar below a transmission tower on the north bank of the Quimi River (see Figure 11), opposite the Quimi tailings dam. Photo taken by the author on 6 November 2018.

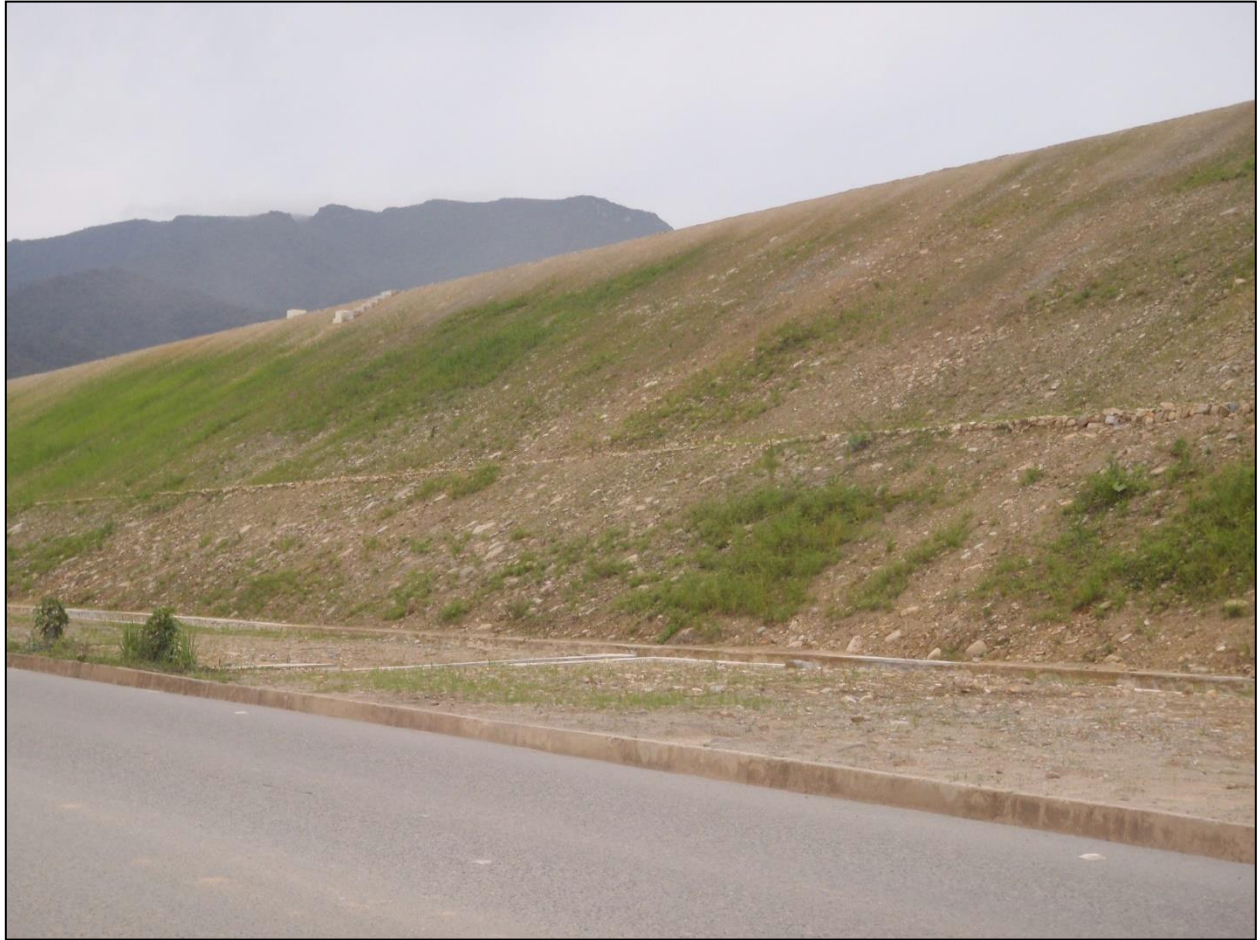
**Figure 16.** The initial dam for the Quimi tailings dam was built at the edge of the road, the other side of which is the river Quimi (see Fig. 11). Since it is not possible to advance the dam further in the downstream direction, the intention must be to construct the entire dam using the upstream method (compare Figures 5a-c). This is inconsistent with the design assessed by Knight-Pièsold (2007) and both Environmental Impact Studies (Walsh Scientists and Engineers, 2010b; Cardno, 2014a), both of which included centreline construction for the Quimi tailings dam. Tailings dams constructed by the upstream method are more susceptible to failure by both earthquakes and flooding. Due to the inability to install impermeable layers (see Figures 5a-c, 8), their higher water content also makes them more susceptible to failure by internal erosion, static liquefaction and foundation failure. Photo taken by the author on 6 November 2018.

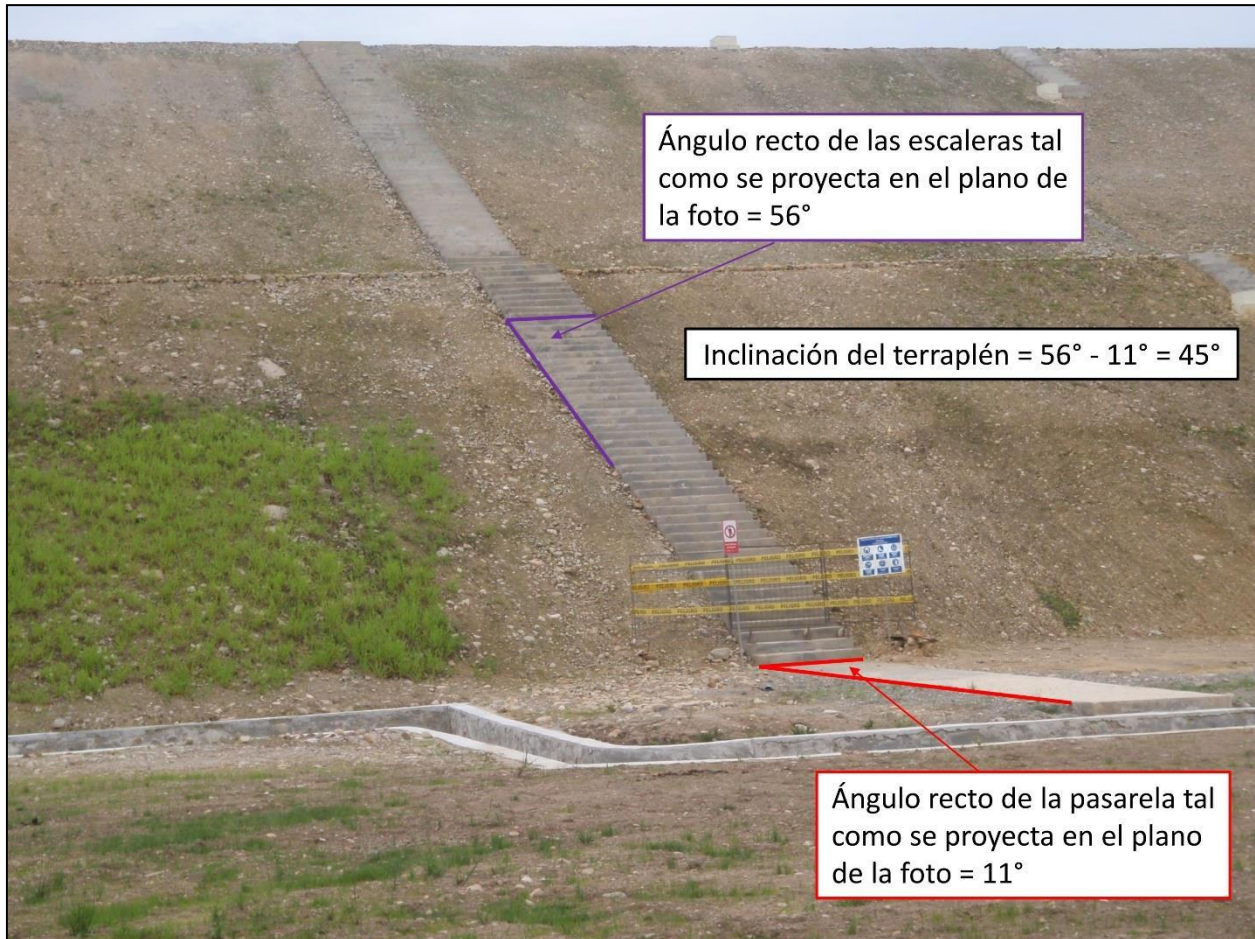
**Figure 17.** The initial embankment for the Quimi tailings dam has a slope of 1V:1H (45°). This is inconsistent with the design assessed by Knight-Pièsold (2007; see Figure 10) and both Environmental Impact Studies, which stated that the slope would be 1V:2H (26.6°). A slope of 1V:1H is considered the maximum critical angle to prevent internal erosion of the dam without any margin of error (factor of safety = 1,0). In contrast, according to the US Army Corps of Engineers (USACE, 2000), "for sand levees, a downstream slope of 1V at 5H [11.3°] is considered sufficiently flat to prevent seepage damage exiting the downstream slope [internal erosion]". Photo taken by the author on 6 November 2018.

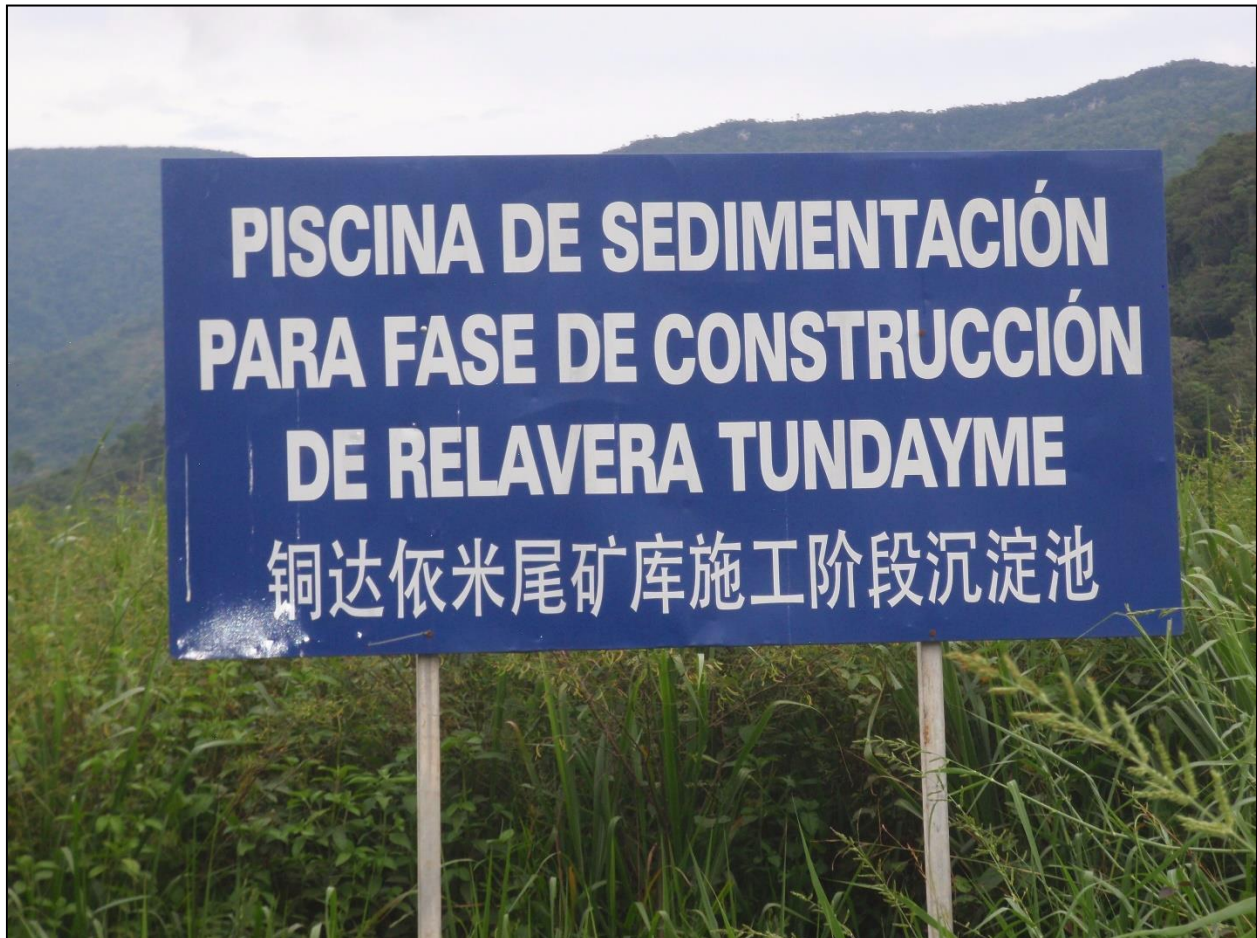
**Figure 18.** The sign makes it clear that both the Quimi tailings dam (see Figures 1, 16 and 17) and the Tundayme tailings dam are currently under construction. This is inconsistent with the Environmental Impact Assessment (Cardno, 2014a), which listed the two tailings ponds as alternatives. Photo taken by the author on 6 November 2018.

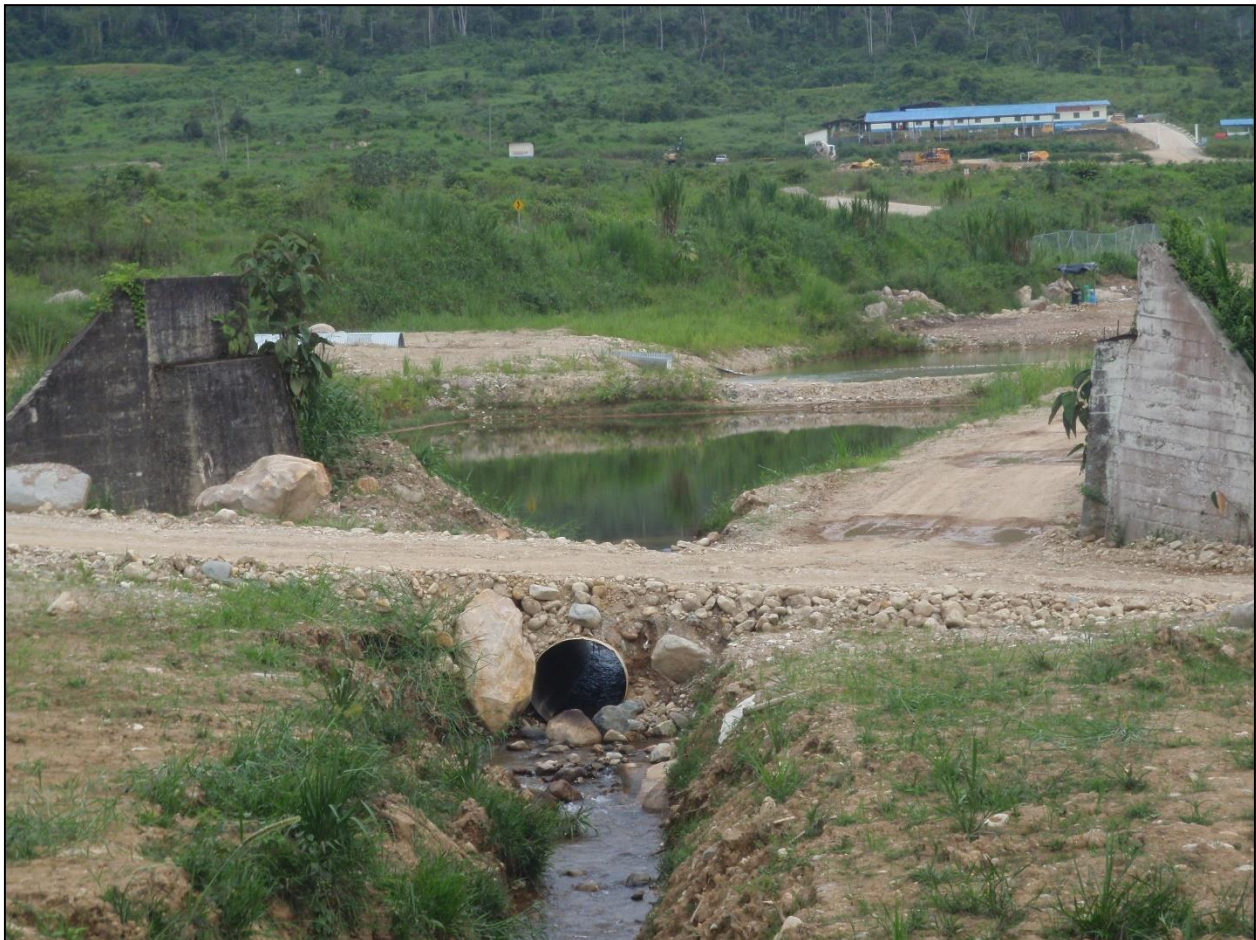
**Figure 19a.** Overflow from the sedimentation ponds for the Tundayme tailings dam is discharged into a pipe and flows into the Quimi River (see Figure 11). Photo taken by the author on 6 November 2018.

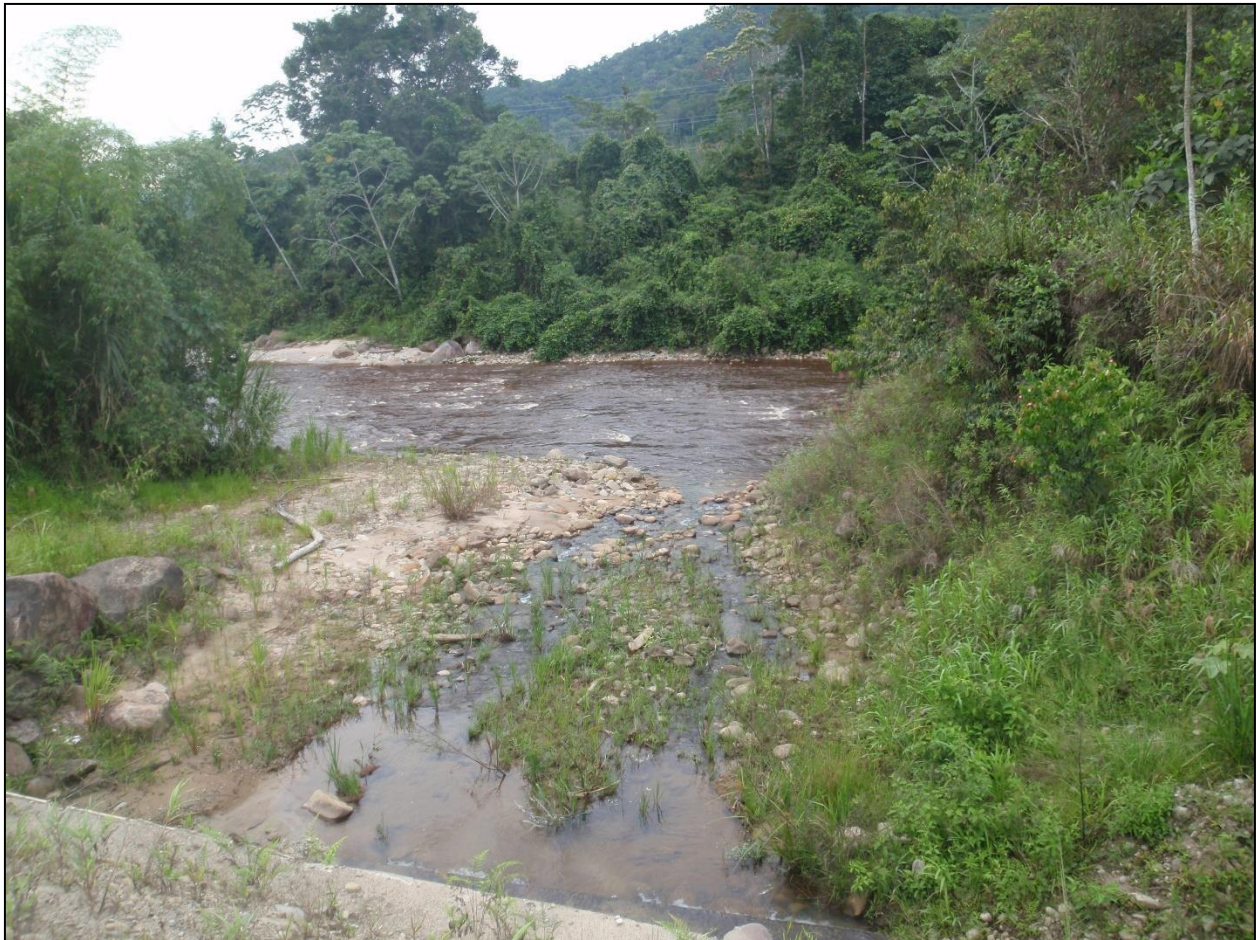
**Figure 19b.** The pipeline from the sedimentation ponds discharges directly into the Quimi River. Photo taken by the author on 6 November 2018.

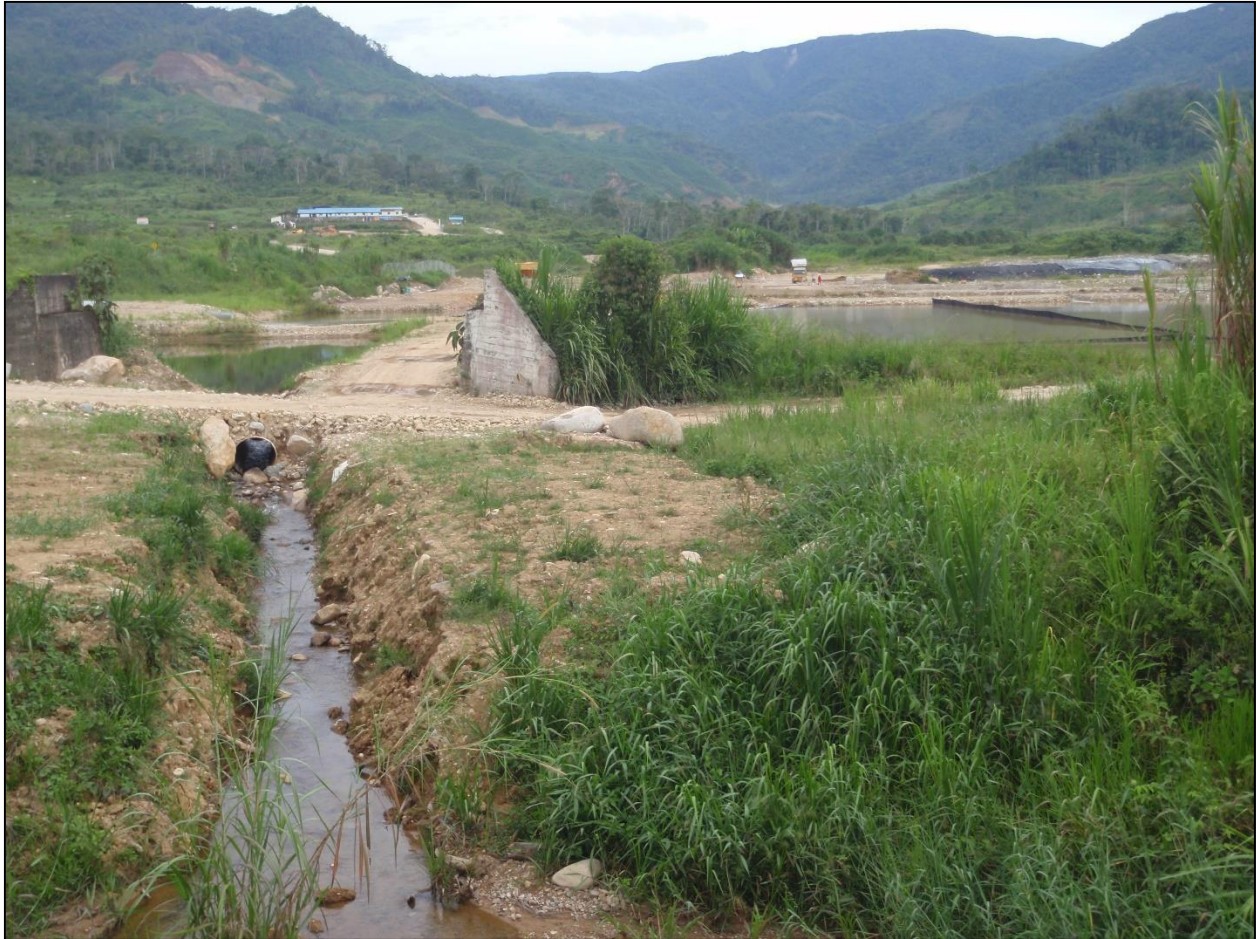
**Figure 19c.** The grey colour of the discharge from the sedimentation ponds shows that the sedimentation ponds are not functioning (Quishpe Lozano et al., 2018). Photo taken by the author on 6 November 2018.

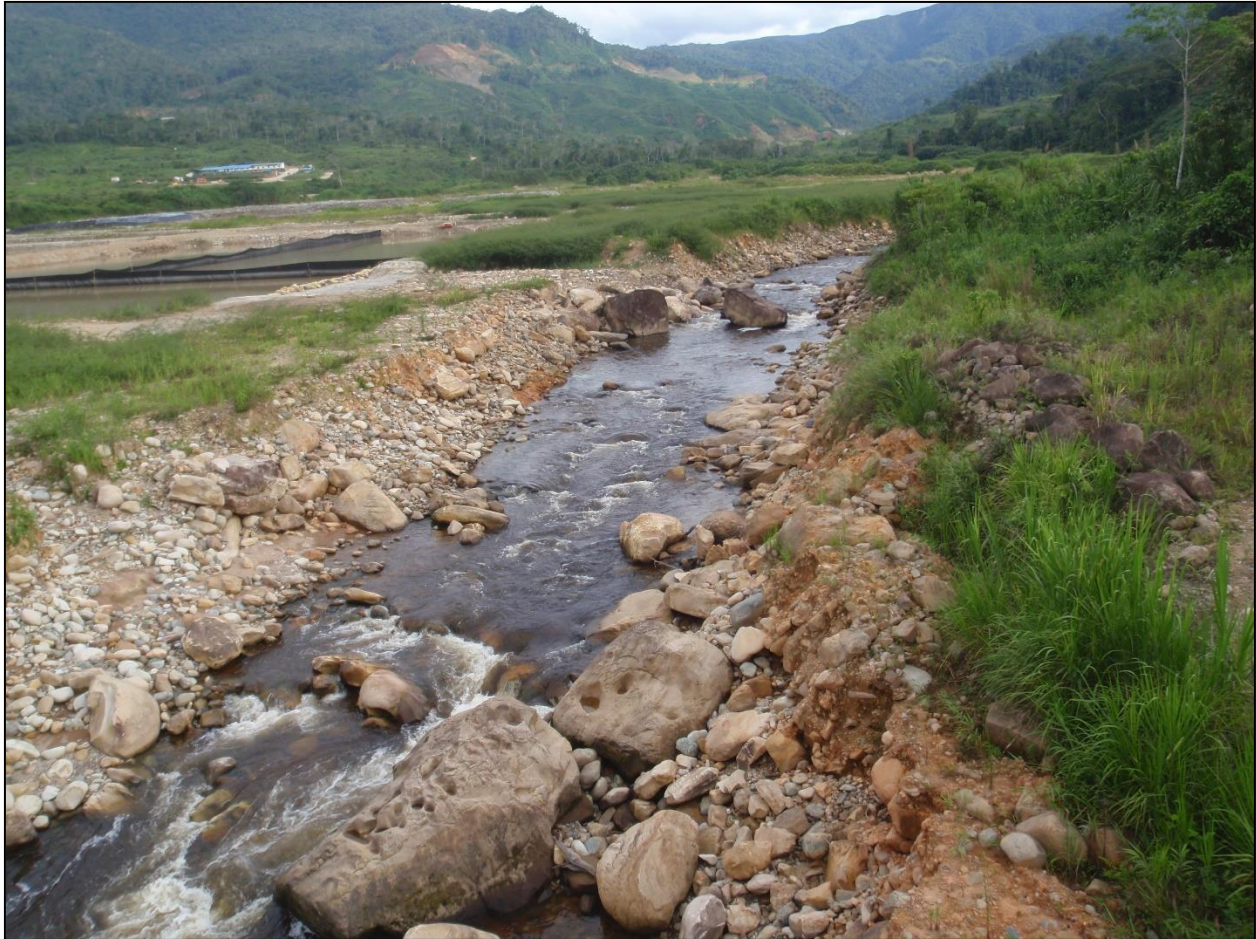
**Figure 20.** According to a complaint by the provincial government of Zamora Chinchipe (Quishpe Lozano et al., 2018), "Here the extraction of stone material was taking place in a portion of the Tundayme River [shown above]. As in the Quimi and Waywayme rivers [see Figures 2 and 11], the extraction of stone material in this area is not carried out within any mining concession for the exploitation of aggregates and stone...It is worth noting that in the review of the national Mining Cadastre, no mining titles for the exploitation of stone material within the Mirador project in the aforementioned area are registered". A possible explanation for the illegal extraction of construction material from the rivers is the lack of other sources of construction material. A shortage of construction material could also explain the change from centreline construction to upstream construction (see Figure 16) and the excessively steep embankment of the initial embankment (see Figure 17). Photo taken by the author on 6 November 2018.
