The potential for imminent danger to human life and the environment from the Mirador open-pit copper mine in south-eastern Ecuador

Submitted to the Inter-American Commission on Human Rights

E-Tech International

Report prepared at the request of E-Tech International  
Submitted 19 February 2019  
Revised 26 February 2019

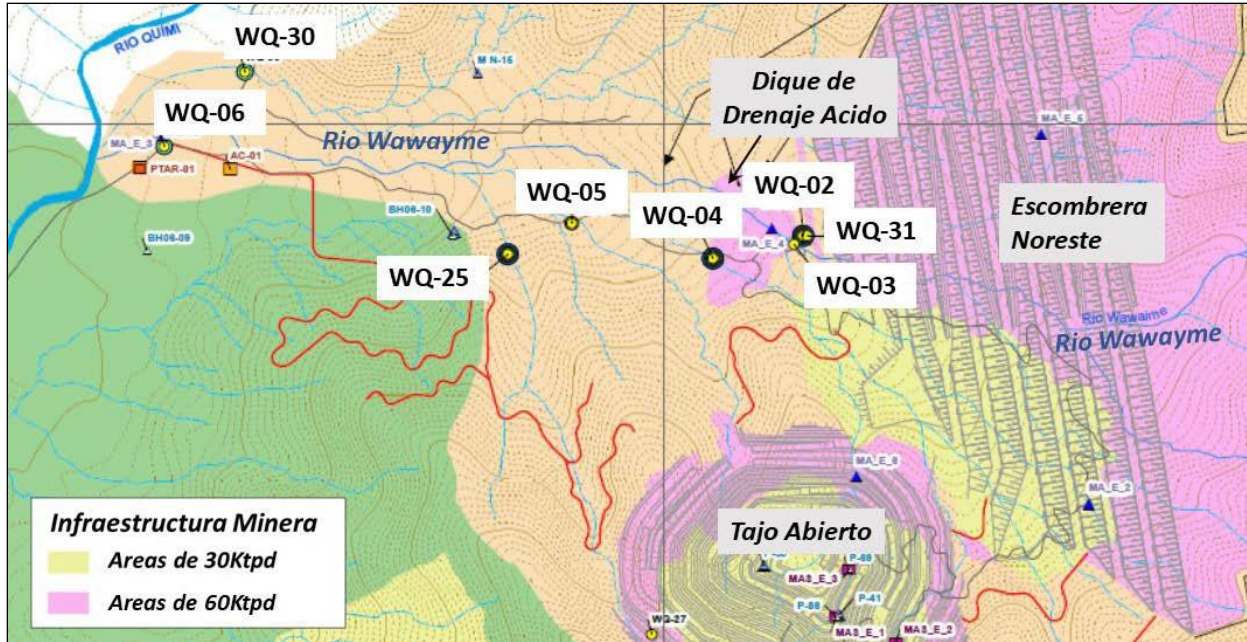
The Wawayme River drains the large rock pile known as the Northeast Sump, and surface water monitoring sites near the amounts and just upstream of where it flows into the Quimo River have exceedances of water quality standards for many metals, including copper, iron, aluminium and lead, manganese and zinc and low pH values (< pH 6). The locations with the highest concentrations of metals and the lowest pH values are WQ-04, WQ-05 and WQ-34, which are in the tributaries of the Wawayme River draining Escombrera Noreste and the open pit (Table 1 and Figure 10<sup>2</sup>). Metal concentrations near the mouth of the Wawayme River (WQ-06) were generally lower and pH values were somewhat higher, according to limited additional data obtained as part of

Figure 10. Surface water sampling locations in the Wawayme River, rock piles and open pit Source: Modified from Cardo, 2014b, Annex D, Map 7.3-12.

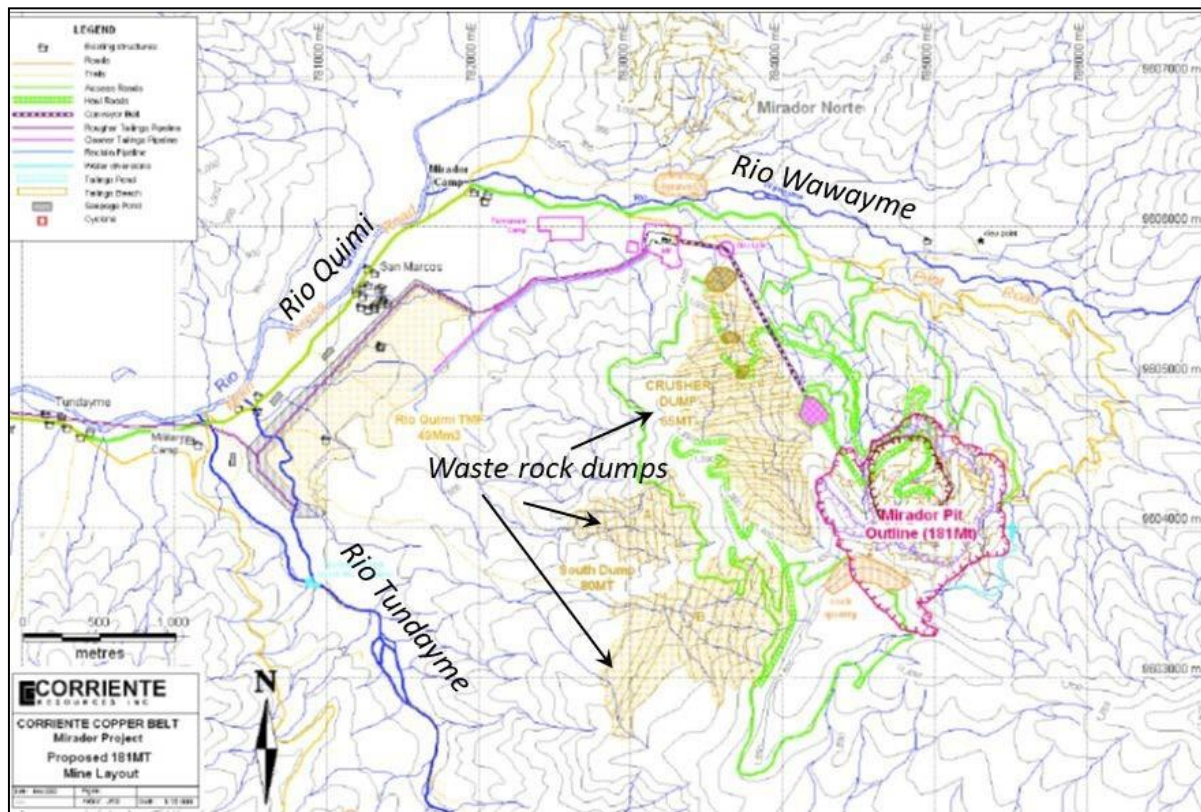
The Contraloría report (2020) also shows elevated concentrations of metals and low pH values in Rio Tundayme and Rio Quimi compared to reference values (IIGE, 2018) and Ecuador's water quality criteria. The upper Tundayme River receives water from tributaries draining the open pit area, and the lower Tundayme River contains the Quimi tailings dam. The 2008 Feasibility Study (Corriente Resources, Inc., 2008) shows that large rock dumps were planned for the west side of the open pit that would drain into the Tundayme River watershed, as shown in Figure 11.

Figure 11. Mine design for 30 000 tonne/day operation showing waste rock piles in the Tundayme and Wawayme catchments.

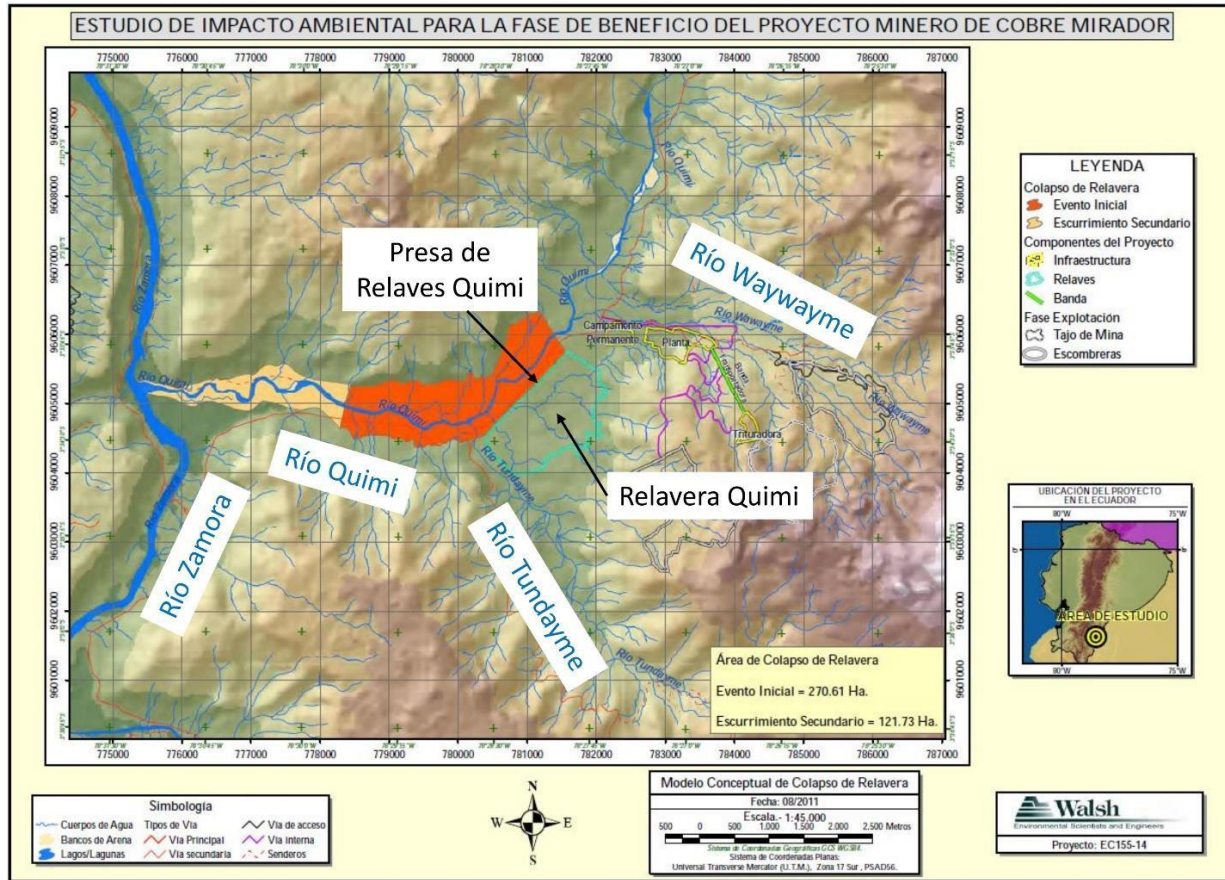
**Figure 2.** The Mirador copper mine is currently under construction by Ecuacorriente S.A. in Zamora Chinchipe, Ecuador. A previous Environmental Impact Assessment (EIA) in 2010 proposed a single tailings dam (called the Quimi tailings dam) and calculated the extent of tailings spillage after dam failure. The extent of the initial event (orange) was calculated using a formula that has been shown to be incorrect. The extent of secondary runoff was not based on any calculation, but was simply a drawing. In fact, the spilled tailings will be transported down the Zamora River to the headwaters of the Amazon River. Figure modified from Walsh Scientists and Engineers (2011b).

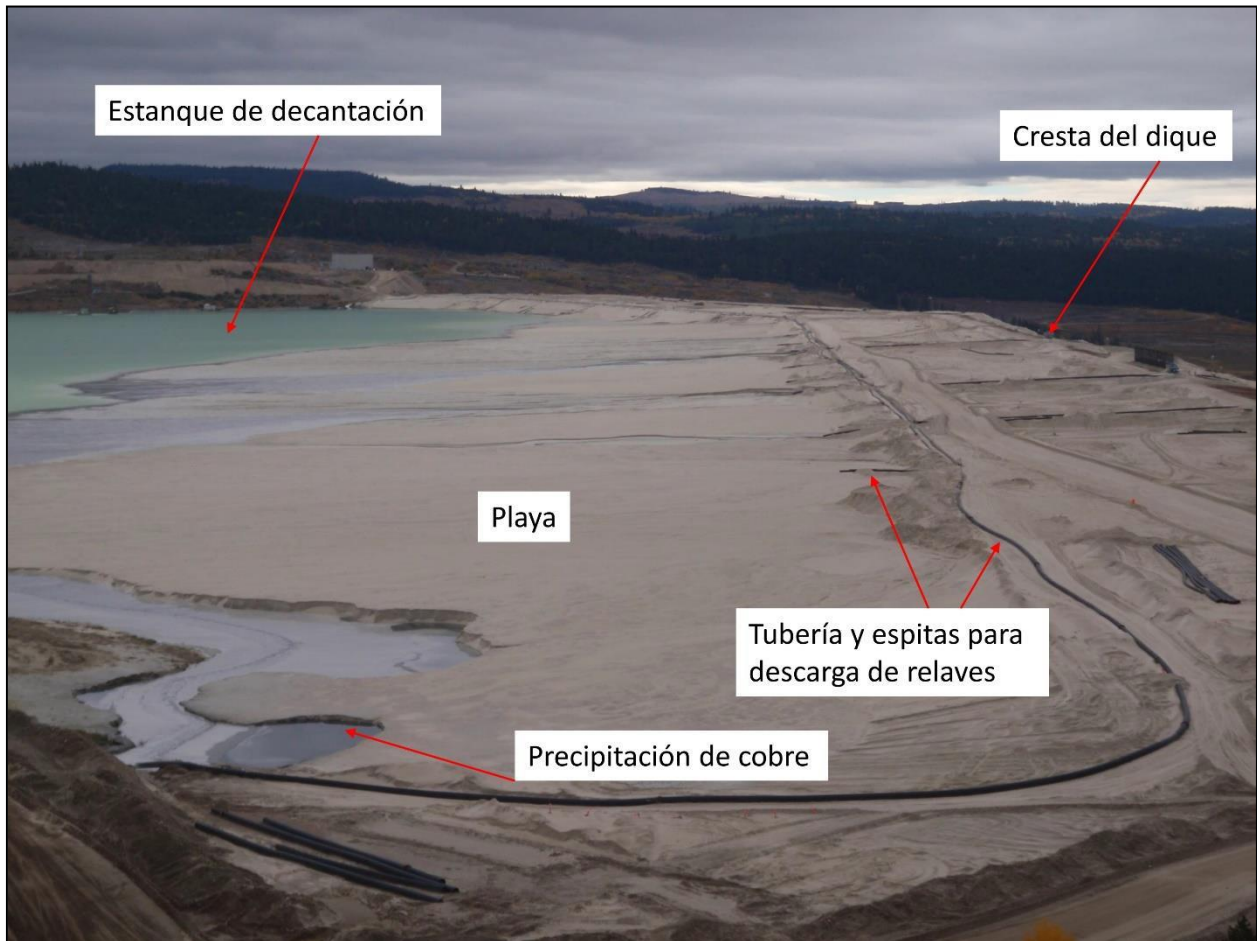
**Figure 4.** At the Highland Valley copper mine tailings storage facility in British Columbia, wet tailings are discharged in the upstream direction from a pipe and spigots along the dam crest. Larger particles (sands) are deposited near the dam to form a beach. Smaller particles (silts) are transported further away from the dam to form a settling pond. Copper precipitation in the tailings pond indicates incomplete extraction of copper from the ore. The narrow beach (especially on the opposite side, where the beach is almost non-existent) makes the dam susceptible to flood failure. Photo taken by the author on 27 September 2018.

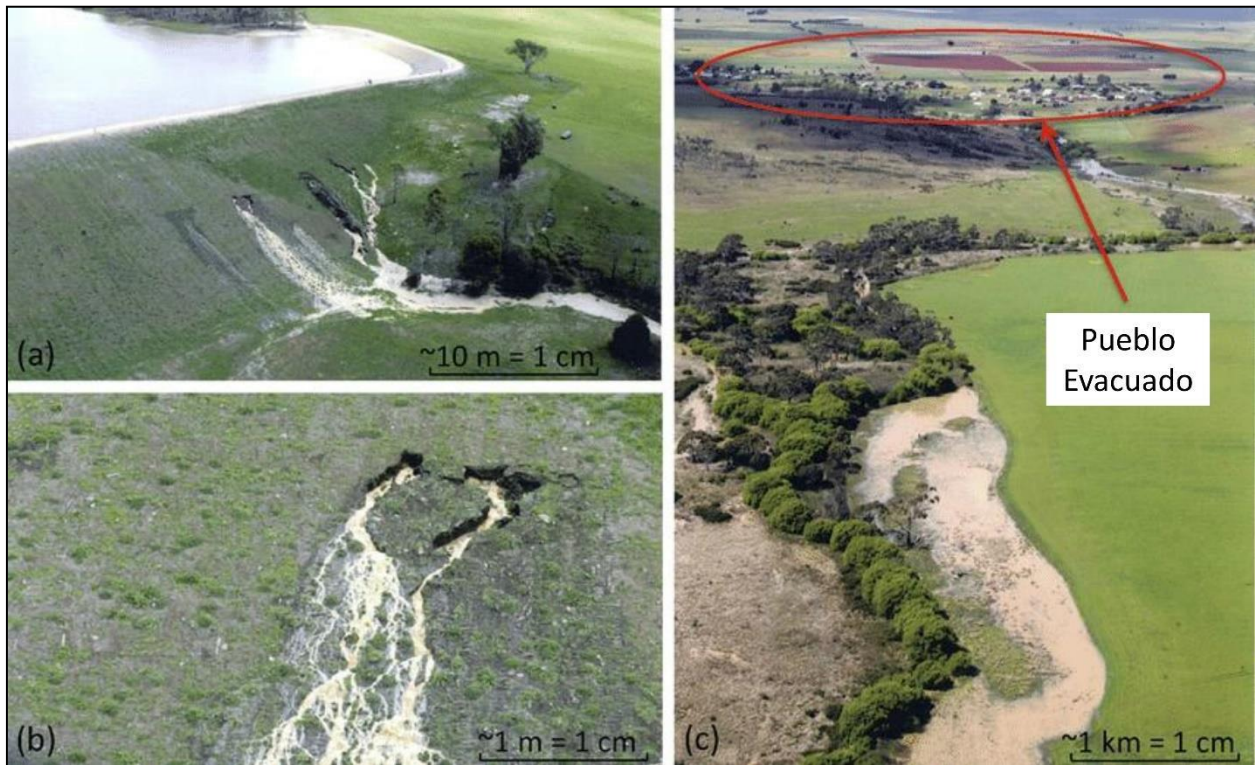
**Figure 7.** Internal erosion (also called channelisation) caused the failure of an earth dam in Tunbridge, Australia, in 2005. During internal erosion, seepage transports solid particles out of the dam so that the dam loses structural integrity. Internal erosion can be considered a type of liquefaction because the water carries the load of the dam. Internal erosion is promoted by an excessively steep embankment slope and the resulting high hydraulic gradient, which forces water to flow through the dam. Photo modified from Fisher et al. (2017).

The final common cause of tailings dam failure is internal erosion, which occurs when water seepage through the dam carries tailings or other construction material out of the dam (see Fig. 7). Internal erosion can create an open channel in the dam (so internal erosion is also called channelisation), causing the dam to lose structural integrity. Internal erosion can be considered a type of liquefaction because the water carries the load of the dam. Internal erosion is promoted by an excessively steep embankment slope and the resulting high hydraulic gradient, which forces water to flow through the dam (note excessively steep embankment slope in Fig. 7). (The hydraulic gradient is the drop in the water table across the dam divided by the length of the dam).

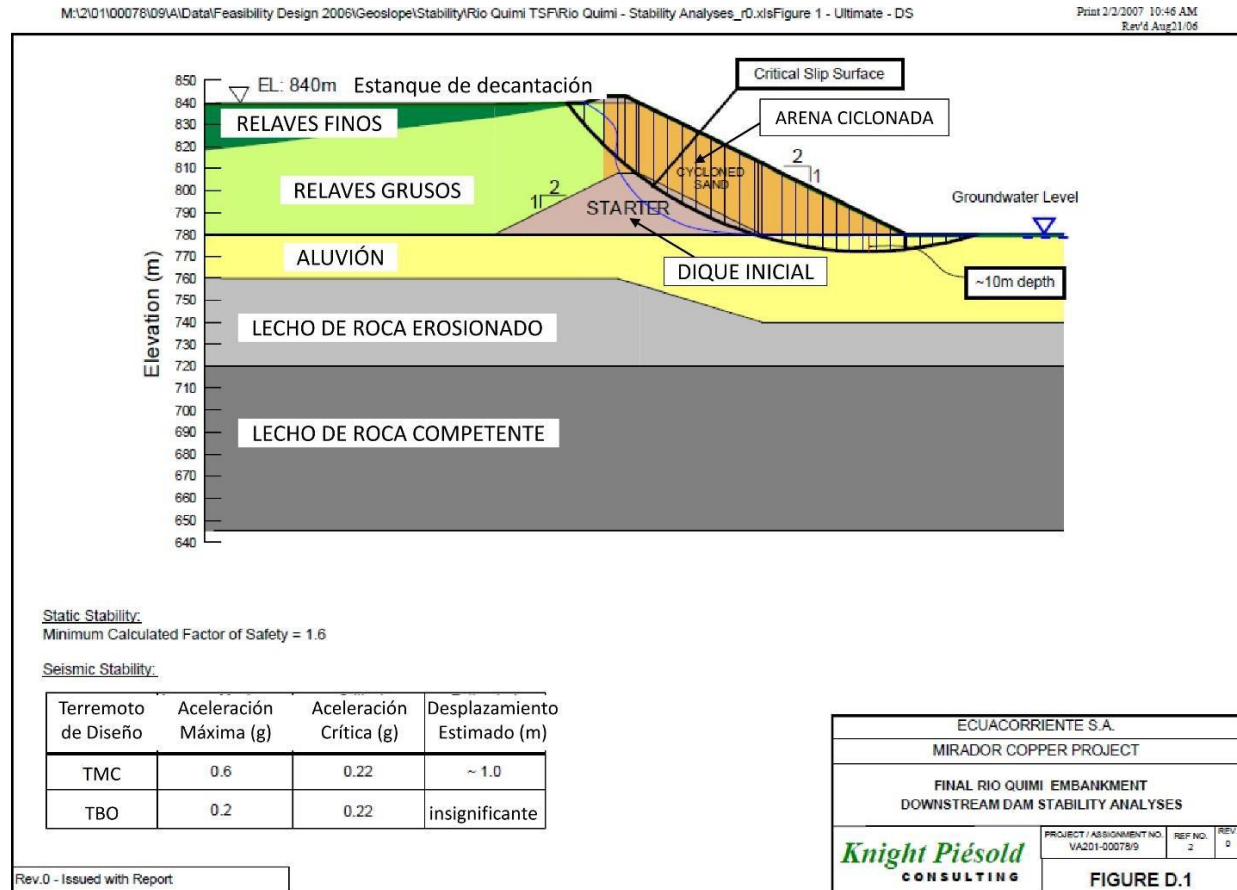
**Figure 10.** Knight-Pièsold (2007), consultants hired by Ecuacorriente S.A., determined that "the entire depth of the tailings deposit is potentially liquefiable for the TDE [maximum design earthquake] and TBO [operational base earthquake]. Liquefaction is also predicted for loose alluvial soils near the surface (in the upper 10 metres) for the TDE and TBO". Knight-Pièsold (2007) identified the TDE with the TMC (maximum credible earthquake). The operational base earthquake is the earthquake expected to occur during the life of the project. Note that the maximum accelerations during the TMC and OBE were predicted to be 0.6 g and 0.2 g, respectively, while the critical acceleration for liquefaction was calculated to be 0.22 g, where g is the acceleration due to gravity. Knight-Pièsold (2007) recommended that "ground improvement will be required to increase the liquefaction resistance of these loose soils within the footprint of the embankment and for a distance downstream of the embankment. Stability analyses indicate that a 100-metre wide area of ground will require treatment along the embankment alignment". However, there were no details or assurances that the "ground improvement" would eliminate the possibility of liquefaction of the foundation. The Knight-Pièsold (2007) diagram clarifies that the previous design of the Quimi tailings dam included centreline construction and an embankment slope of 1V:2H. Figure modified from Knight-Pièsold (2007).

The critical part of the Knight-Pièsold (2007) review was the seismic stability analysis, which stated that "*the entire depth of the tailings deposit is potentially liquefiable for the MDE and OBE [Operating Base Earthquake]. Liquefaction is also predicted for the loose alluvial soils near surface (in the upper 10 meters) for the MDE and OBE*" [the entire depth of the tailings deposit is potentially liquefiable for the MDE and OBE [Operating Base Earthquake]. Liquefaction is also predicted for the loose alluvial soils near the surface (in the upper 10 meters) for the MDE and OBE] (see Fig. 10). The OBE is the earthquake expected to occur during the life of a project. Knight-Pièsold (2007) defined the OBE as the earthquake with a return period of 475 years, which is equivalent to an annual exceedance probability of 0.21% and an exceedance probability over the 30-year life of the project of 6.13%. In other words, Knight-Pièsold (2007) stated that the probability was 6.13% that the entire tailings mass, as well as the foundation, would be subject to seismic liquefaction at some point during the 30-year life of the project. However, it should be noted that the risk of seismic liquefaction does not end at the end of the mining project, but continues forever as the dam is assumed to store the wet tailings in perpetuity. Knight-Pièsold (2007) recommended that "*Ground improvement to increase the liquefaction resistance of these loose soils will be required within the embankment footprint and for a distance downstream of the embankment. Stability analyses indicate that a 100 meter wide zone of ground will require treatment along the embankment alignment*" [Ground improvement to increase the liquefaction resistance of these loose soils will be required within the embankment footprint and for a distance downstream of the embankment. Stability analyses indicate that a 100 metre wide area of ground will require treatment along the embankment alignment]. However, there were no details or assurances that "ground improvement" would eliminate the possibility of liquefaction of the foundation. There is no evidence that this type of seismic stability analysis was ever repeated, even as the proposed height of the tailings dam increased.

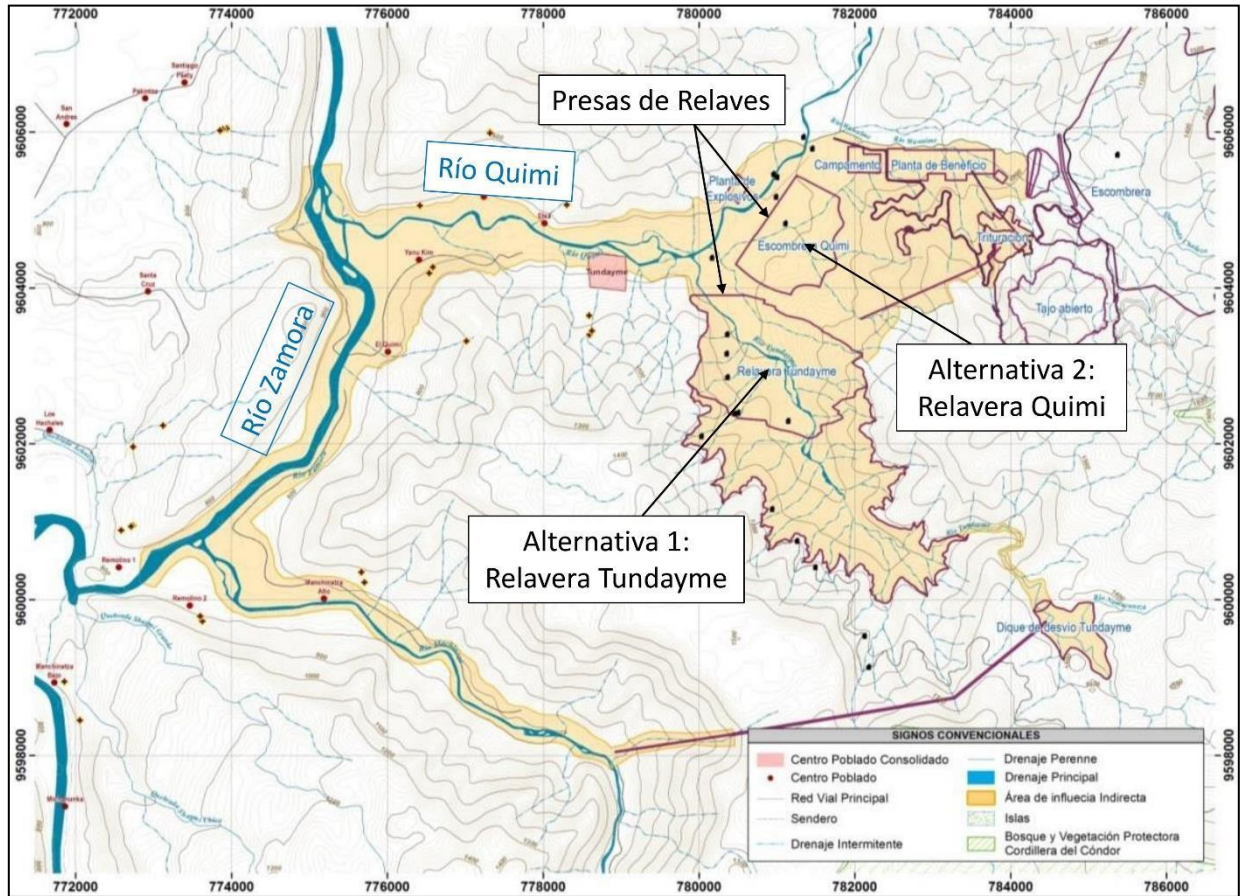
**Figure 11.** The second Environmental Impact Assessment (Cardno, 2014a) proposed two alternatives for increasing the

copper ore production of 30,000 to 60,000 tonnes per day. Alternative 1 was to replace the Quimi tailings dam with the Tundayme tailings dam, for which the dam would be 260 metres high, the highest tailings dam ever built. Alternative 2 was to maintain the Quimi tailings dam, but increase its capacity by dewatering the tailings. Alternative 1 was preferred because of its lower cost, although it would have a greater environmental impact (Cardno, 2014a).
